# Sustainable Rehabilitation Measures for Degraded Lands in Kuwait

<sup>1,2,3</sup> Crisis Decision Support Program, Kuwait Institute for Scientific Research, Kuwait

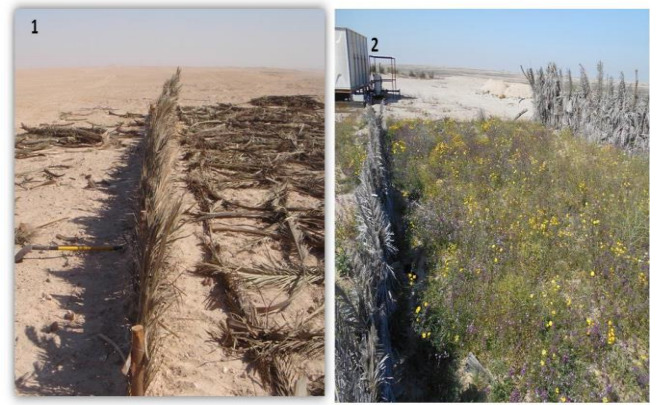
At the top of the hill, this technique brings into effect a set of square bunds arranged as a checker board pattern and the building of two permeable palm barriers. This system consists of a series of small square bunds made of from palm leaves and arranged as checker board design and two permeable palm barriers to reduce wind speed and to block the water flow and spread it on the adjacent plain and enhance infiltration. The wetted area is then used for crop production (Fig. 2).

Fig. 2.. Soil before treatment (2) After rehabilitation for two years  
*Square micro catchment*

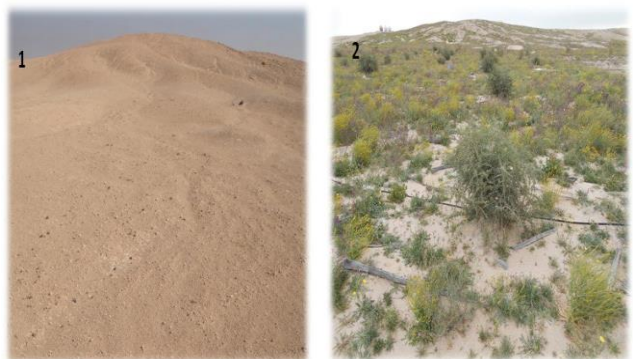
It consists of a series of square runoff basins arranged along degraded playa. Each square bunds covered 25m<sup>2</sup> area and 30 cm height, native plant cultivated in each square and date palm leaves mulched the entire area of micro catchment (Fig. 3). Mulching sheet retain soil moisture and reduced evaporation, thus minimized need of watering. The palm mat acted as insulating blanket. It kept soil cooler in summer and warmer in winter

Fig. 3. (1) Soil before treatment (2) After three years of rehabilitation.

The main results were reached after the application of square micro catchments for one year duration. The average infiltration capacity has increased by 74.418 cm<sup>3</sup>/min in control soil to 111.8625 cm<sup>3</sup>/min in the treated soil. The average differences in volume of infiltrated water was 33.5%. Mulching sheet retained soil moisture and

reduced evaporation, thus minimizing the need of watering. A new layer of soil with an average height 26.2 cm was trapped above the mulched palm leaves with in an area 2500m<sup>2</sup>. The volume of new trapped layer of soil was 109.2 m<sup>3</sup>. The trapped sand accumulated above mulching materials rich in essential elements and organic materials and consider as seed banks played role in the growth and activation of new plant species. (Table 2and 3)

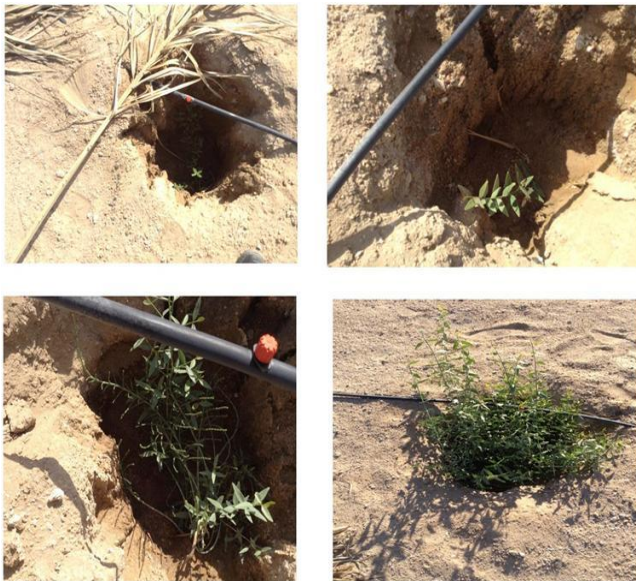
For one meter or more, deep pits were drilled deeply to deeply depending on where the soil moisture was rich and high. These pits were filled with 3-4 liters of water. After 24 hours the top soil in the pit was ploughed to allow the penetration of oxygen. Manure was added and mixed with the fresh top soil. Healthy seedlings of *native plant* were cultivated inside the deep pits system (Fig. 4). These pits act as rain catchment areas and amplify soil moisture. The goal of creating deep pits was to allow the seedling to survive from soil moisture that existed in the depths. Majority of the native plants are drought resistant and respond well to limited irrigation.

Fig. 4. Cultivation of *Salvadora persica* in pit system.

The technology of pit system aims to cultivate desert flora without relying on irrigation methods known, this technique relies on the plant to take advantage of ground soil moisture where there is an available water capacity stored in soil and can be available for growing of plant. Seedling can irrigate them self from soil moisture that exist in the depths. Most native plants are drought resistant respond well to limited irrigation. Examples of native resistant plants are *Ziziphus spina-christi* , *Lycium shawii* , *Salvadora persica*, *Haloxylon salicornicum* and *Nitraria retusa*. little irrigation may be more desirable than continuous irrigation as many desert species are very sensitive to overwatering. (Table 4) 13).

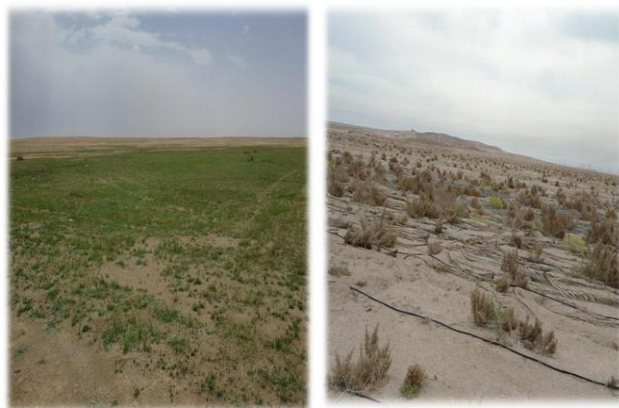
A temporary dominant community type of annual shrub colonizes around > 10 cm thick on smooth sand sheet can play a major role in stabilizing and improving soil quality and creating better microenvironments for growing perennial native plants such as conglomerates of *Rhanterium epapposum*, *Haloxylon salicornicum* and *Cyperus*. For example, the group of *Cornulaca* is one of the most abundant and dominant shrubs in the rehabilitated area of Liyah. It has the potential to grow around artificial lakes, playas, disturbed land, everywhere. *Cornulaca* spp is a native plant equipped with a range of physical and behavioral processes to thrive in an arid system. It has the ability to trap mobile aeolian sediments and stabilize soil through forming nabkha. (Fig. 5).

Fig. 5. Protection of temporary annual community Plantation on sand accumulation body

Annual community has potential for managing the environment as natural types used in desert areas to restore degraded lands. Plantation on sand accumulation body created a suitable microenvironment for plantation of native plant along the bottom of sand body

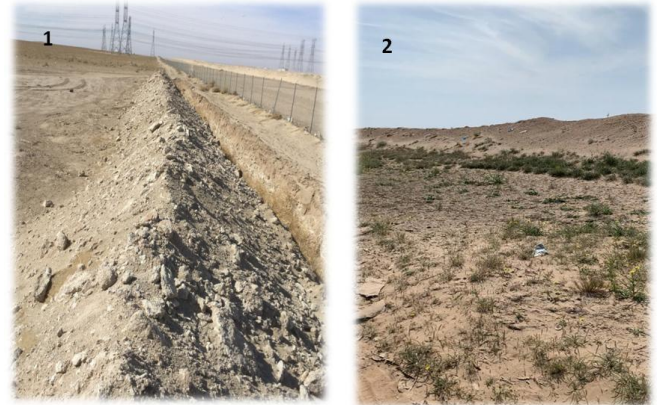
The accumulation of sand near the fence for protection issues played a major role to achieve environmental balance. The body of sand acted as

shield that protects the plant from sand blowing, provides stocks of rain water and stockpile of seeds. All these factors create a suitable microenvironment for plantation of native plant along the bottom of sand body (Fig. 6).

Fig. 6. (1) Soil before treatment (2) After plantation.
